Hot Dip Galvanising (HDG)

Important Considerations before Choosing to Paint HDG Steel

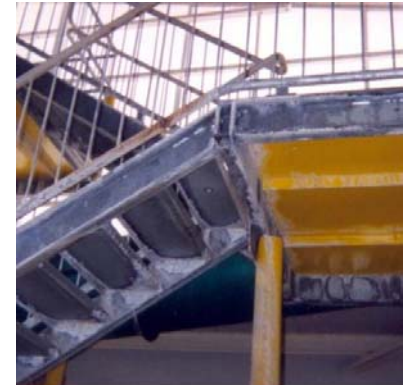
Severe zinc depletion of HDG steel in a new swimming centre. Red rusted areas indicate complete zinc layer depletion and steel corrosion. Extensive rectification work delayed the opening of the pool and blew out project costs.
