## Hot Dip Galvanising (HDG)

**1.2.6**

### Troubleshooting problems associated with painted HDG Steel

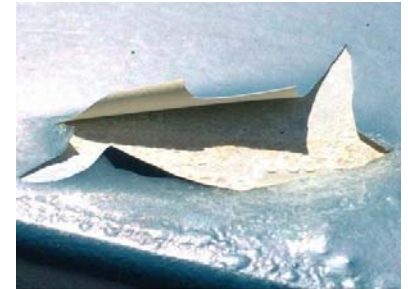
- **Inadequate degreasing** prior to painting.
- **Insufficient abrasion** prior to painting - look for a shiny surface on the underside of the paint flakes.
- **Excessive primer film build** if a single pack etch primer was used.
- **Incorrect coating choice** (eg an alkyd primer or topcoat applied directly to the surface – see Dulux Protective Coatings Tech Note No. 1.2.5).

White rusting of zinc layer caused delamination of the coating

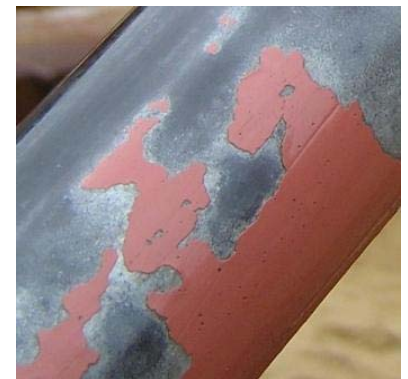
- Insufficient **number of coats**.
- Insufficient **coating thickness**.
- Use of **acid wash** during preparation.
- Excessive **temperature/humidity** (eg used under insulation on ducting).
- Inconsistent **coverage** (eg misses, pinholes, edges not stripe coated, handling/erection damage not repaired).
- **Chemical Exposure** - (eg ducting & purlins in swimming centres with chlorinated/heated pools).
- **Contamination between coats** - eg primed in shop then taken to site for storage and erection before topcoating.
- **Insufficient cleaning** of the galvanised surface - contaminants not removed prior to painting.

Little or no surface profile on the substrate caused coating failure.

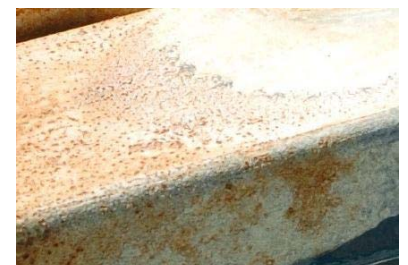
- **Insufficient film build** of zinc layer – **zinc depletion**.
- **Excessive abrasion**, removing too much of the galvanising.
- **Damage** to galvanising **not repaired** prior to painting (eg cut edges, grinding, welding should be repaired with a zinc rich primer, swarf from cutting, grinding etc not removed prior to painting).

Inadequate zinc layer was quickly depleted, allowing steel substrate to corrode
