Hot Dip Galvanising (HDG)

Important Considerations before Choosing to Paint HDG Steel

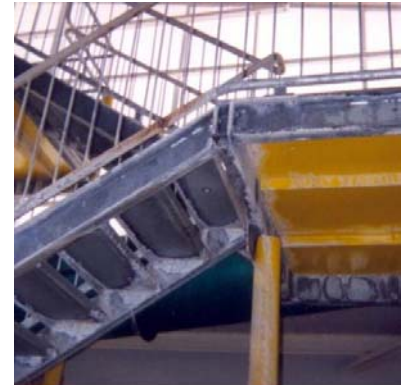
Severe zinc depletion of HDG steel in a new swimming centre. Red rusted areas indicate complete zinc layer depletion and steel corrosion. Extensive rectification work delayed the opening of the pool and blew out project costs.

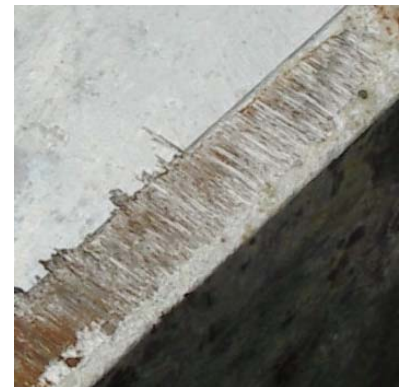
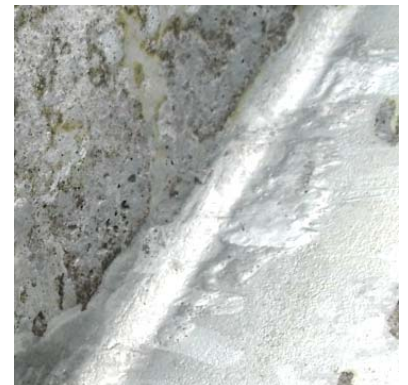
- Possible **air pockets** and blisters in the hot dip galvanising within the angles of the metal section – such defects are almost impossible to detect.

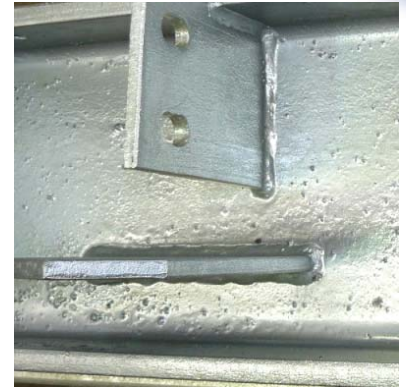
- **Inability to coat the full surface** – sometimes sections are welded together in such a way that brushes, rollers or spray units cannot reach. Fixings can also reduce access of application tools.
- **Fixings** – fixings can present several challenges when painting; if the fixing is of a different metal to that of the section in which it is fixed (or even a different grade of the same metal) and the two are in contact, a small current will result and corrosion will occur. A non-conducting isolator must always separate fixings from the surrounding metal. Isolators are usually made of flexible plastic and therefore can present paint adhesion problems. When applying paint, pooling¹ can occur around the base of the fixing, resulting in excessive film builds and possible mudcracking².

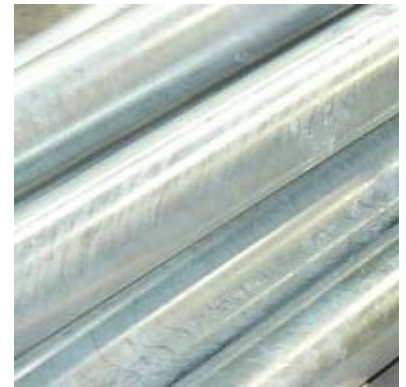
- **Insufficient abrasion** – surface profile is not high enough for the coating system to key into, resulting in loss of adhesion.
- **Dags/lumps** of galvanising not removed – apart from the disappointing appearance of the painted steel, dags are often poorly bonded to the steel, and can simply drop off, particularly in response to steel expansion and contraction when subject to hot/cold temperature cycling.
- **Acid wash** – the traditional acid etching method of HDG steel would often result in traces of acid residues being entrapped under the coating system, causing deterioration of the galvanising layer and subsequent coating failure. Hence acid etch is no longer considered a viable method of surface preparation.

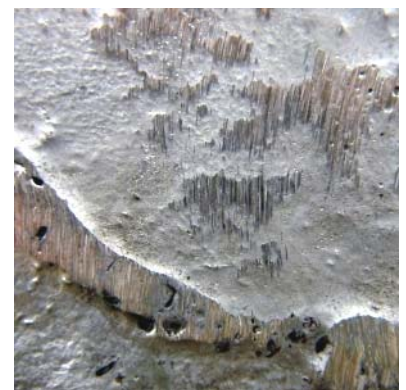
- Insufficient film build - the wet film thickness of a coating is quite easy to measure using a wet film build gauge, but hot dip galvanising thickness is much more difficult to measure and rectify.
- Incorrect coating - eg alkyd enamels saponify on contact with zinc³
- Surface is not fully encapsulated - misses, difficult to reach areas.
- Handling and erection damage not repaired - similar effect as misses.
- On site storage prior to application - potential surface contamination.
